Ready for remediation

THE BAY OF ÖRSERUM PROJECT

65 years of effluent from the paper mill

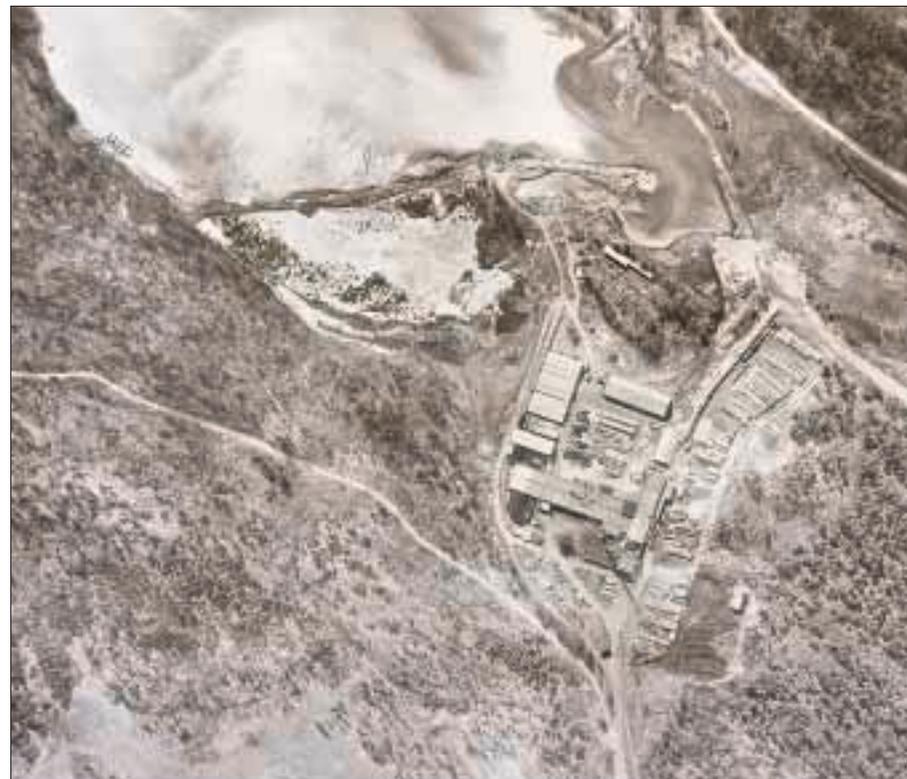
A birds-eye view from the 1960's clearly shows the extensive pollution in the Bay of Örserum.
PHOTO RIKETS ALLMÄNNA KARTVERK

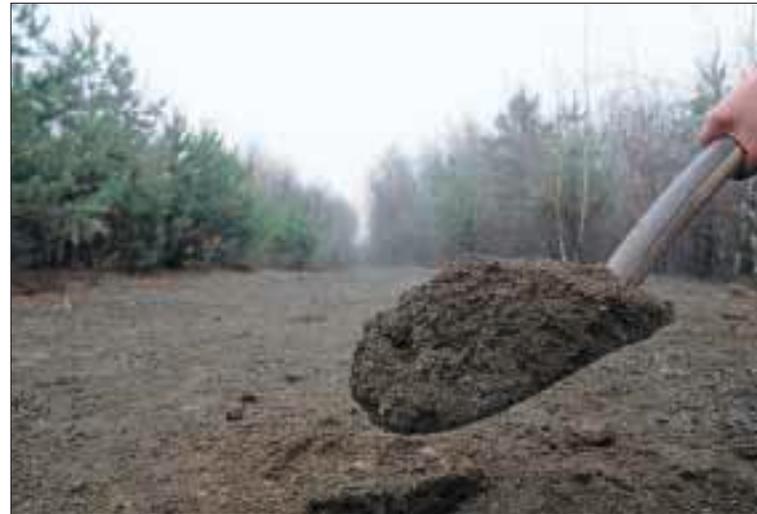
PCB and mercury now evaporate into the air from the old deposit of fibre-rich masses.

The great quantities of fibre that were deposited on shore above the basin contained considerable quantities of water. This caused the “hill” of fibres to partly flow out into the basin inside the bank.

Now that the fibre-rich masses have dried out there is a risk that they will now be spread by the wind.

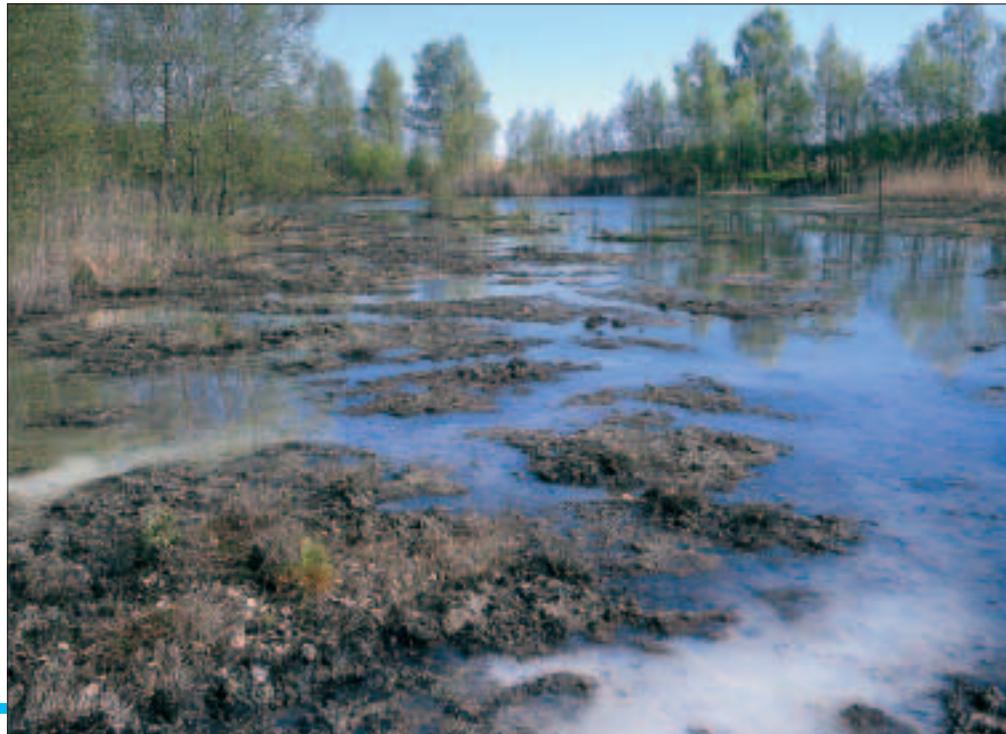
This is the old basin in the inner area of the Bay of Örserum into which the effluent from the Paper Mill was released. The basin is now a “bottomless” pit of fibres and loose mud.

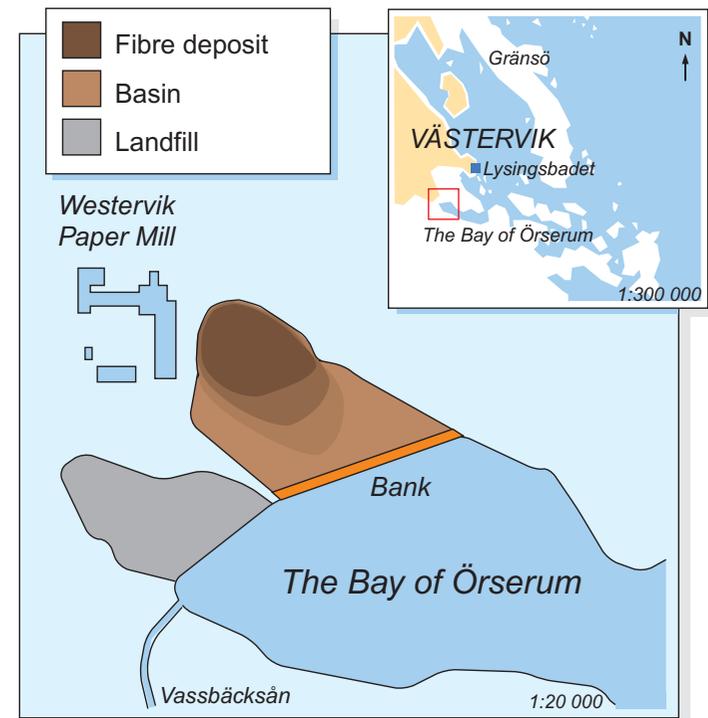
Calculations show that 400 g PCB, 500 g PAH and 190 g mercury leak out of the Bay of Örserum each year.

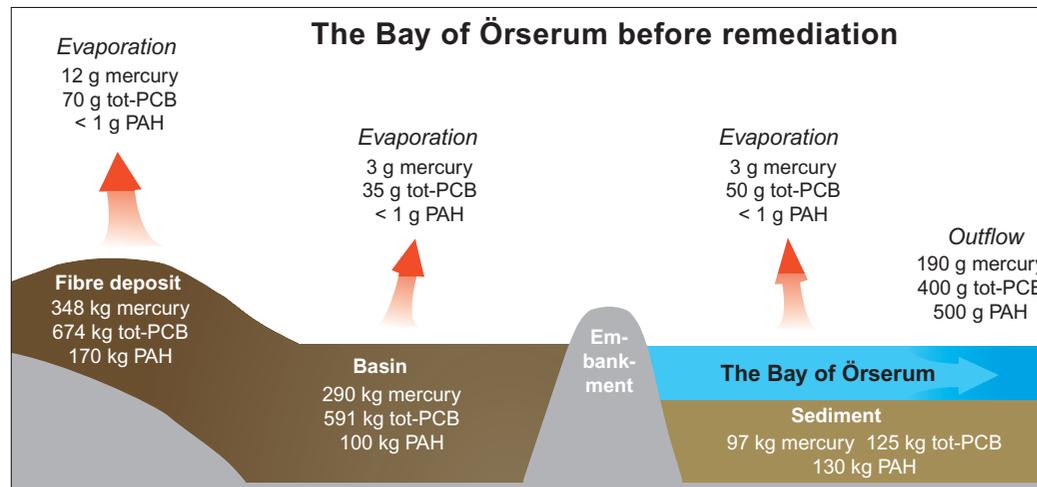
The values of evaporation and outflow have been calculated from investigations done in 1999-2000.

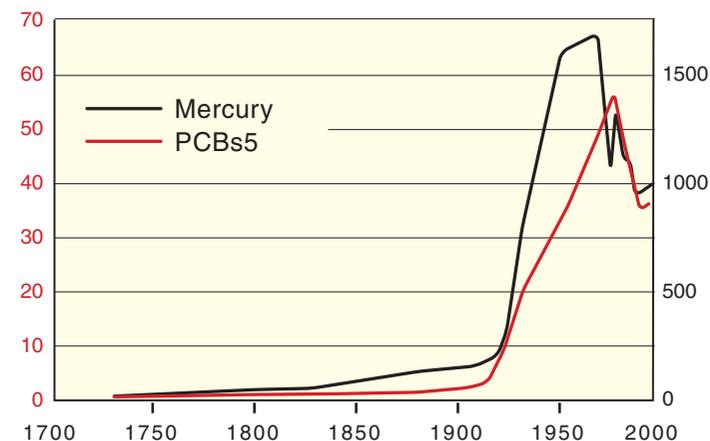
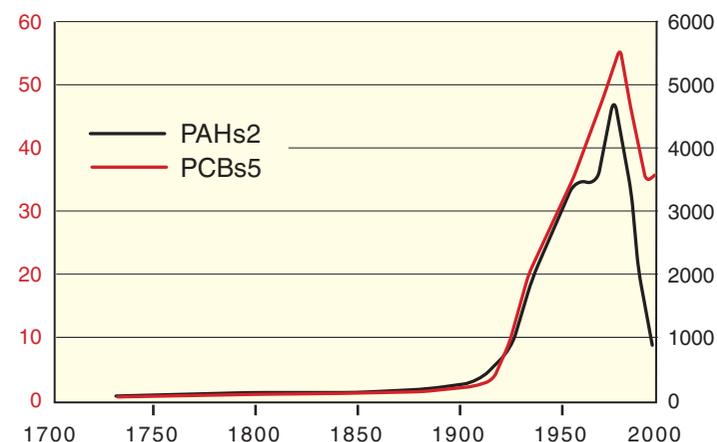
The curves show the levels of PCBs5, PAHs2 och mercury in the coast sediment outside Västervik. The levels are measured in nanograms per gram dry weight (ng/g dw). Note that the scales are different for the different substances. The deeper levels show a raise in level due to turbulence in the sediment. The notation PAHs2 and PCBs5 contain two types of PAH and five types of PCB. This means that the curves show only 20-25 % of the total quantity of PCB in the sediment.

The sediment has been dated from the 18th century up until today. The sediment cores that have been analysed at each centimetre in depth show that the environmental pollution exists in all levels as far down as 20 cm, with the highest levels between 8 and 12 cm. This indicates that the pollution has started to develop in the bay bed from the middle of the 20th century. The levels increased steadily until the 1980's when the plant was closed down and have thereafter decreased.

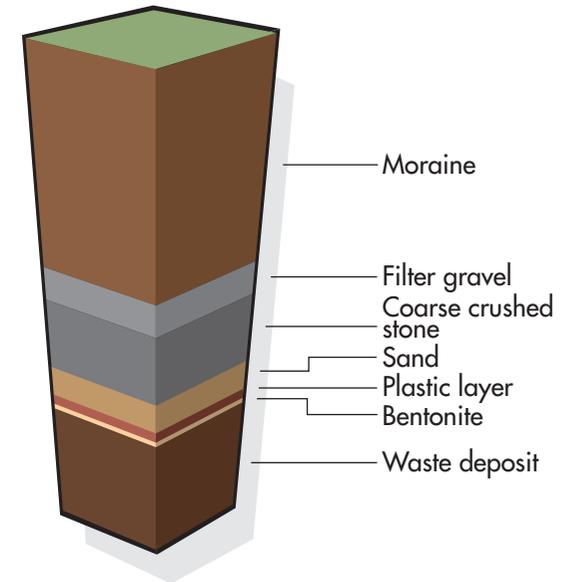
Principle of the waste covering

The landfill is to be regarded as long-term deposition of the polluted masses. In order so as not to repeat the mistakes of the first attempt in 1978–1979 the landfill will be covered over. The cover is intended to ensure that further pollution from the evaporation of PCB and mercury does not occur, and to stop storm water from seeping through the landfill and causing pollution by leakage. The cover will consist of several layers using a technique that has been used in several

similar remediation projects and in covering environmentally dangerous waste. The technique can be compared with that of a well made up bed with a two metre thick blanket of multiple layers.

This design will create a safe deposit for the waste materials and at the same time not prohibit the future “peeling off” of the cover in order to purify the masses at a later date with new, as yet unknown, technology. Improvement in this field is developing rapidly in many countries. The most advanced technology available at the moment is too expensive and such funds are not available for such large quantities as those of the Bay of Örserum. Calculations show that a landfill designed as proposed will leak a small quantity of pollutants during a long period of time. Even if the protective cover is damaged, the pollutant leakage will be so slow as to allow the environment to cope with the problem.

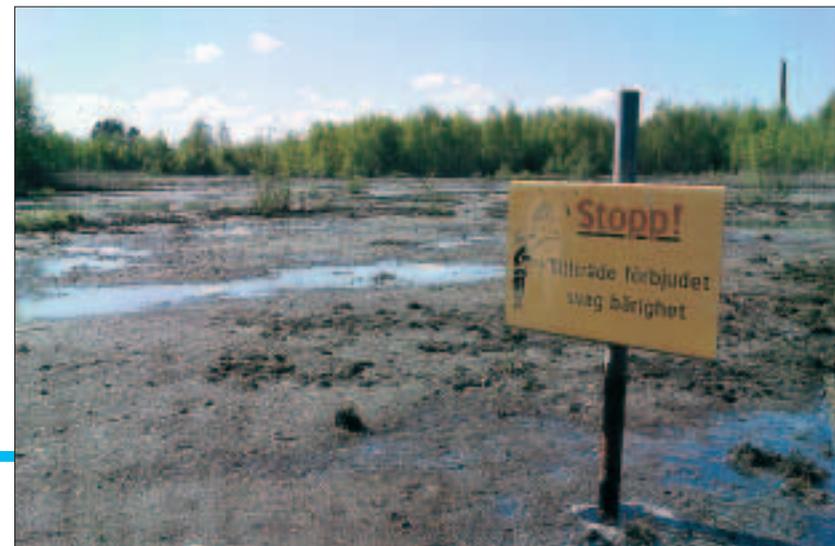
“Here but no further” – this is where the PCB and mercury from the bay is to be deposited.

The landfill to be used is the old basin behind the embankment, in other words land that is already polluted. The embankment will be strengthened in order to avoid collapse due to overload before the masses are replaced.

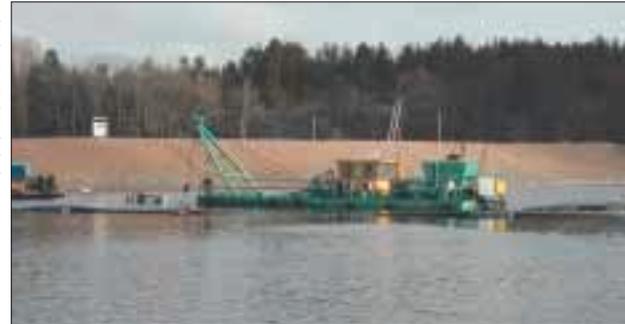
The dredging of the Bay of Örserum started in April 2002. The operation is carried out from a dredger that carefully sucks up the sediment. The slurry is pumped on shore through a buoyant pipe.

Approximately 170 000 m³ of the sediment in the Bay of Örserum will be dredged. The dredging process will be carried out using a dredger that first cuts out the bottom sediment and then sucks it and the surrounding water up in order to minimise re-suspension of the sediment. The resulting masses will be pumped ashore where the water will be drained off and purified and thereafter pumped back into the bay. The resulting masses are then sufficiently solid as to be landfilled.
